# Manhole Inspection Summary

Manhole # S51AA\_030MH

Insp Date: **3/3/08 1:47 PM**

**Location** Address: **Curley-Linwood**

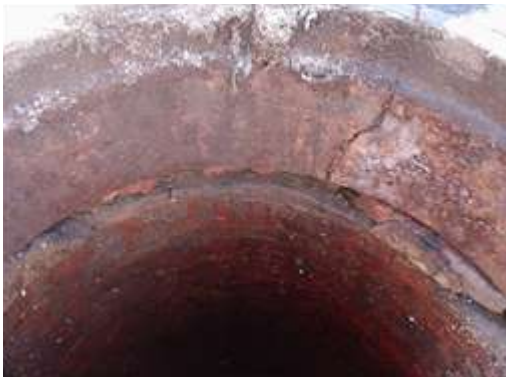
Defect 1

**Chimney / Frame Adjustment** ☒ Exists Material: **Brick** ☐ Parged Height: **6** (in.)

Condition: ☐ Sound ☐ Cracked ☐ Root Intrusion ☒ **Loose Brick** ☐ Deteriorated

Infiltration: ☐ None ☐ Joint ☐ Cracks ☐ Mortar ☐ Roots ☒ **Wall**

Adjustment Joint

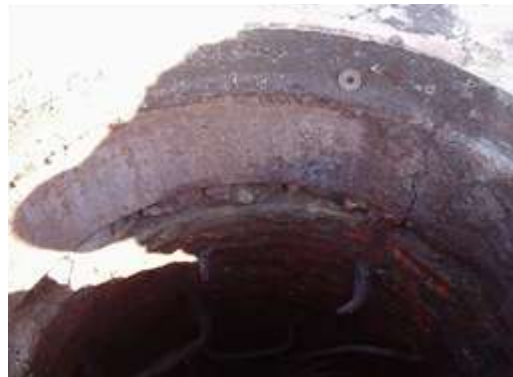
Defect 2

**Frame** Offset: **0.5** (in.) Condition: ☐ Sound ☒ **Cracked** ☒ **Leaks**

Frame Leaks

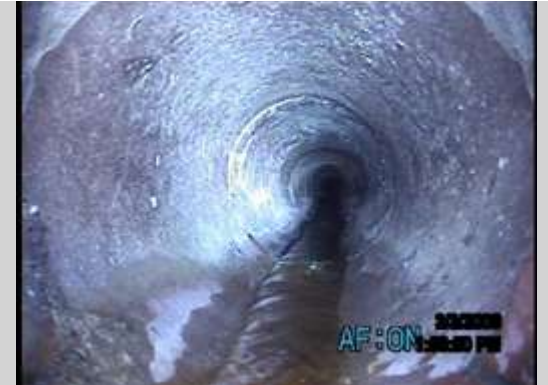
12 O'Clock Outflow

8 in. Circular Gravity Sewer  
Pipe Out @ 12 O'Clock

Pipe Height: **8.4** (in.) Rod and Bar (Angled)  
Pipe Material: **Clay** ☐ Pipe Lined  
Invert Depth: **9.20** (ft.) Flow Characteristics: **Fast**  
Deposits: ☒ None ☐ Mud ☐ Sludge ☐ Debris ☐ Grease  
Silt Depth: (in.) Deposits Extent:  
Infiltration: **None** Pipe Seal Cond: **Sound**

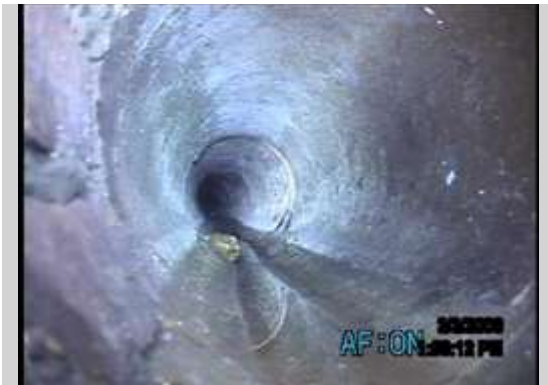
3 O'Clock Inflow

8 in. Circular Gravity Sewer  
Pipe In @ 3 O'Clock

Pipe Height: **8.4** (in.) Rod and Bar (Angled)  
Pipe Material: **Clay** ☐ Pipe Lined  
Invert Depth: **9.10** (ft.) Flow Characteristics: **Slow**  
Deposits: ☒ None ☐ Mud ☐ Sludge ☐ Debris ☐ Grease  
Silt Depth: (in.) Deposits Extent:  
Infiltration: **None** Pipe Seal Cond: **Sound**

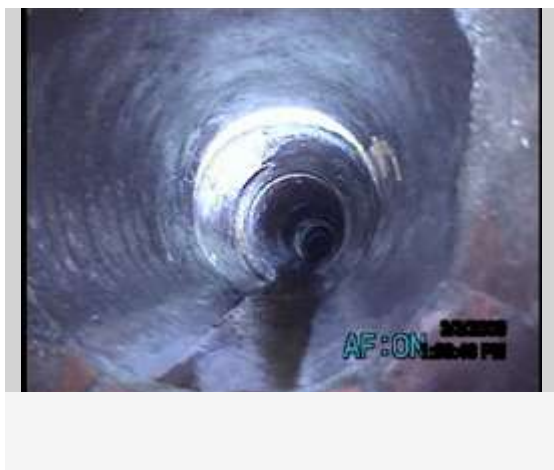
9 O'Clock Inflow

8 in. Circular Gravity Sewer  
Pipe In @ 9 O'Clock

Invert Depth: **8.50** (ft.) Flow Characteristics: **Fast**

Infiltration: **None** Pipe Seal Cond: **Sound**
